# Manhole Inspection Summary

Manhole # S23C1\_005MH

Insp Date: **7/7/08 9:20 AM**

**Location** Address: **2426 Hollins Ferry Rd**

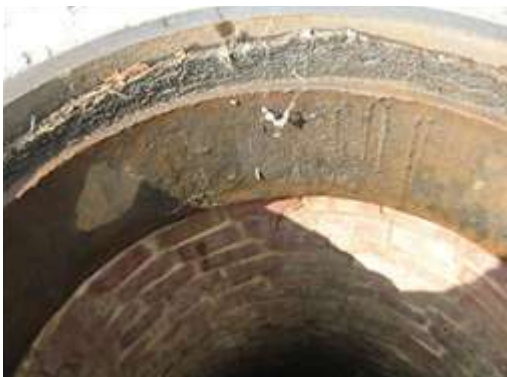
Defect 4

**Frame** Offset: **1.5** (in.) Condition: ☐ Sound ☐ Cracked ☒ **Leaks**

frame leaks

1.5" offset

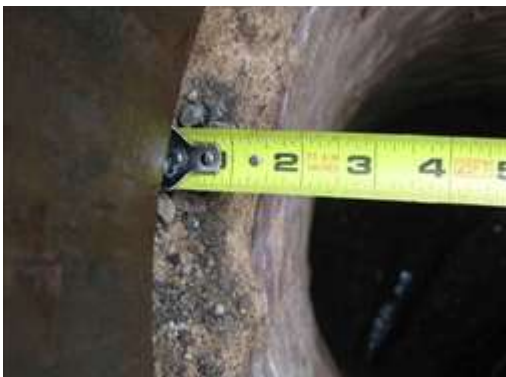
Defect 5

frame view

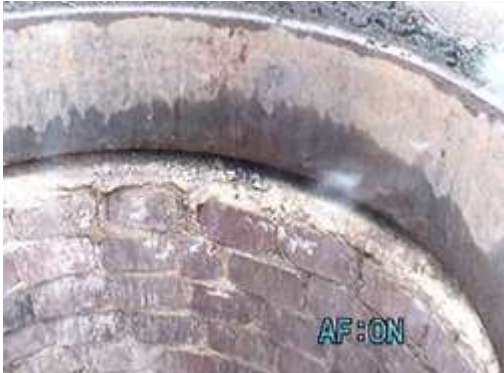
Defect 3

Infiltration: ☐ None ☒ **Joint** ☐ Cracks ☐ Mortar ☐ Roots ☐ Wall

chimney joint infiltration

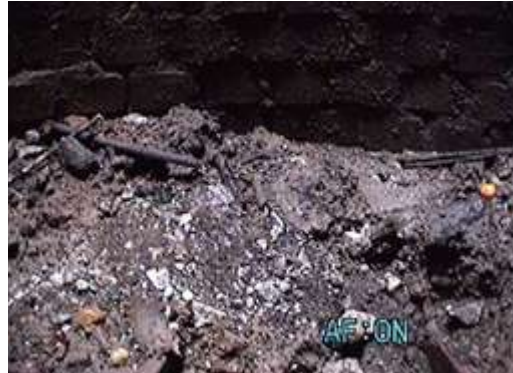
Defect 2

Condition: ☐ Sound ☐ Cracked ☐ Root Intrusion ☒ **Deteriorated** ☐ Leaks ☒ **Debris**

debris on bench

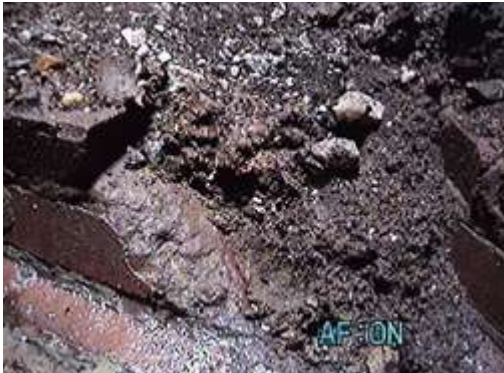
Defect 1

channel-bench broken; bh - intended channel for additional connection

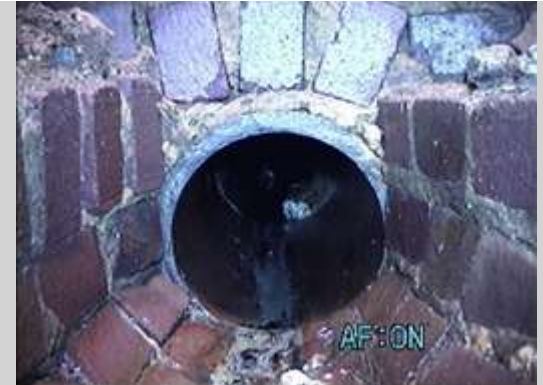
12 O'Clock Outflow

8 in. Circular Gravity Sewer  
Pipe Out @ 12 O'Clock

Pipe Height: **8.4** (in.) Rod and Bar (Angled)  
Pipe Material: **Clay** ☐ Pipe Lined  
Invert Depth: **12.95** (ft.) Flow Characteristics: **Slow**  
Deposits: ☒ None ☐ Mud ☐ Sludge ☐ Debris ☐ Grease  
Silt Depth: **0** (in.) Deposits Extent:  
Infiltration: **None** Pipe Seal Cond: **Sound**

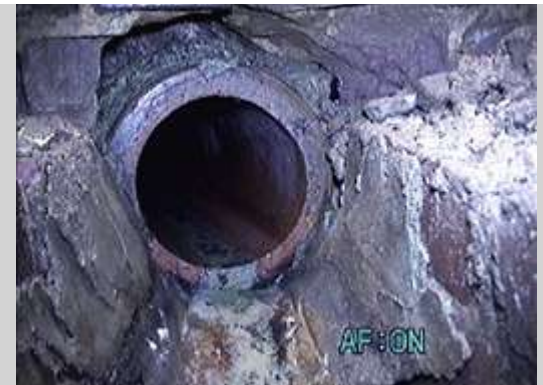
5 O'Clock Inflow

6 in. Circular Gravity Sewer  
Pipe In @ 5 O'Clock

Pipe Height: **6** (in.) Rod and Bar (Angled)  
Pipe Material: **Clay** ☐ Pipe Lined  
Invert Depth: **12.31** (ft.) Flow Characteristics: **Slow**  
Deposits: ☒ None ☐ Mud ☐ Sludge ☐ Debris ☐ Grease  
Silt Depth: **0** (in.) Deposits Extent:  
Infiltration: **None** Pipe Seal Cond: **Sound**
